**Flood Control Project Maintenance  
Levee Inspections**

**Maintenance Issue Types Only, Levee Inspection Report By Mile - Fall 2018**

**Reclamation District No. 2107 Mossdale Island**

Waterway	Bank	Unit Miles	Inspection Start/End	Inspector
Unit No. 01 San Joaquin River	Left	2.33	10/03/2018 10/03/2018	Zach Jojola

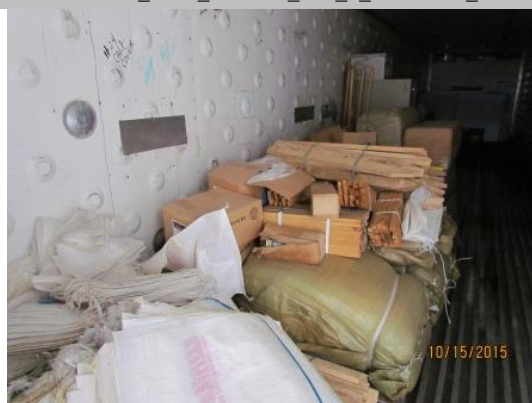
Photo 1 of 1 : FA\_2018\_RD2107\_329\_7\_20180911\_00001.jpg

LM Start		Rating **	A	Issue No.	7
LM End		Issue Type +	Ma	Location *	
Category	Earthen Levee		GPS Latitude/Longitude		
			Start	End	
Item	Emergency Supplies & Equipment				
DWR ID	DWR_RD2107_01_s_2013_7				
Comment Code					
Inspector Comment					
Flood fighting supplies are available on-site.

View of the flood fight emergency supplies.

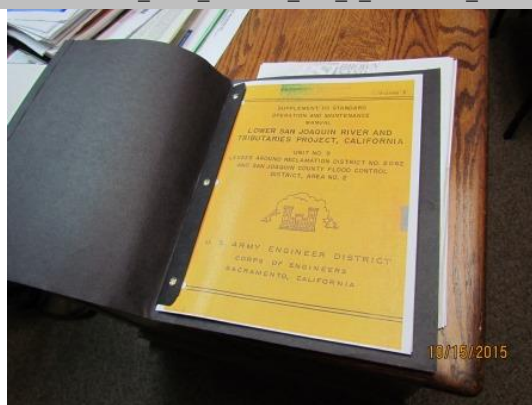
Photo 1 of 1 : FA\_2018\_RD2107\_329\_8\_20180911\_00002.jpg

LM Start		Rating **	A	Issue No.	8
LM End		Issue Type +	Ma	Location *	
Category	Earthen Levee		GPS Latitude/Longitude		
			Start	End	
Item	Operations & Maintenance Manuals				
DWR ID	DWR_RD2107_01_s_2013_8				
Comment Code					
Inspector Comment					
The O&M Manual is available at the LMA's office.

View of the O&amp;M Manual.

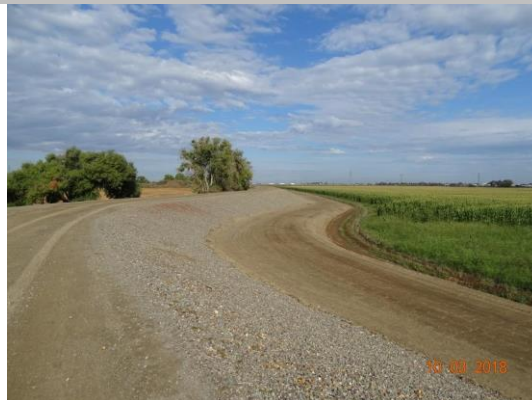
Photo 1 of 1 : FA\_2018\_RD2107\_330\_4\_20181003\_00009.jpg

LM Start	0.19	Rating **	A	Issue No.	4
LM End	0.19	Issue Type +	Ma	Location *	LS
Category	Earthen Levee			GPS Latitude/Longitude	
				Start	End
Item	Vegetation			37.761773 °	37.761773 °
				-121.312566 °	-121.312566 °
DWR ID	DWR_RD2107_02_f_2018_4				
Comment Code					
V1 : Control annual grass and weeds on the levee slopes and easements.					
Inspector Comment					
The LMA maintains the vegetation at a high level.

View of the maintained landside slope and seepage berm. Fall 2018.

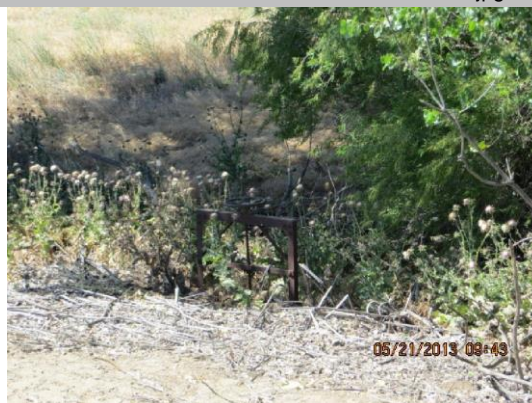
Photo 1 of 2 : UCIP\_FA\_2018\_13637\_22299.jpg

LM Start	0.27	Rating **	M	Issue No.	5	
LM End	0.27	Issue Type +	Ma	Location *		
Category	Supplemental			GPS Latitude/Longitude		
				Start	End	
Item	DWR UCIP LMA Responsibility			37.762613 °	37.762613 °	
				-121.313480 °	-121.313480 °	
DWR ID	19057					
Comment Code						
Inspector Comment						
FS_ID:13637						
DS_ID:19057						
EP_NO: N/A						
Repair Type: Non-Urgent						
Crossing Status: Found						
UCIP Comments: Pipe filled in with soil around outlet and not visible on LS. Appears abandoned and should be done so properly.						
FIELD_STRUCT_DESC: *ABANDONED* 16-inch steel drainage pipe, 16 feet below the crown. Slide gate on the waterside (WS) toe.						
[Additional Reference(s): DWR Levee Log, 2005. USACE San Joaquin O&M Manual 9, April 1964, (HLM 0.27)].						
FS Date: 5/21/2013

Slide gate visible on WS toe.

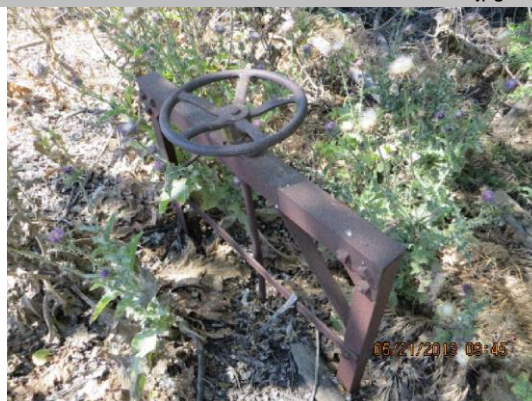
Photo 2 of 2 : UCIP\_FA\_2018\_13637\_22298.jpg

LM Start	0.27	Rating **	M	Issue No.	5 (cont)	
LM End	0.27	Issue Type +	Ma	Location *		
Category	Supplemental			GPS Latitude/Longitude		
				Start	End	
Item	DWR UCIP LMA Responsibility			37.762613 °	37.762613 °	
				-121.313480 °	-121.313480 °	
DWR ID	19057					
Comment Code						
Inspector Comment						
FS_ID:13637						
DS_ID:19057						
EP_NO: N/A						
Repair Type: Non-Urgent						
Crossing Status: Found						
UCIP Comments: Pipe filled in with soil around outlet and not visible on						
LS. Appears abandoned and should be done so properly.						
FIELD_STRUCT_DESC: *ABANDONED* 16-inch steel drainage pipe,						
16 feet below the crown. Slide gate on the waterside (WS) toe.						
[Additional Reference(s): DWR Levee Log, 2005. USACE San Joaquin						
O&M Manual 9, April 1964, (HLM 0.27)].						
FS Date: 5/21/2013

Slide gate visible on WS toe.
